Debris/Ice/TPS Assessment And Photographic Analysis For Shuttle Mission STS-37

April 1991

Gregory N. Katnik
NASA/Kennedy Space Center

DEBRIS/ICE/TPS ASSESSMENT
AND
PHOTOGRAPHIC ANALYSIS
OF
SHUTTLE MISSION STS-37

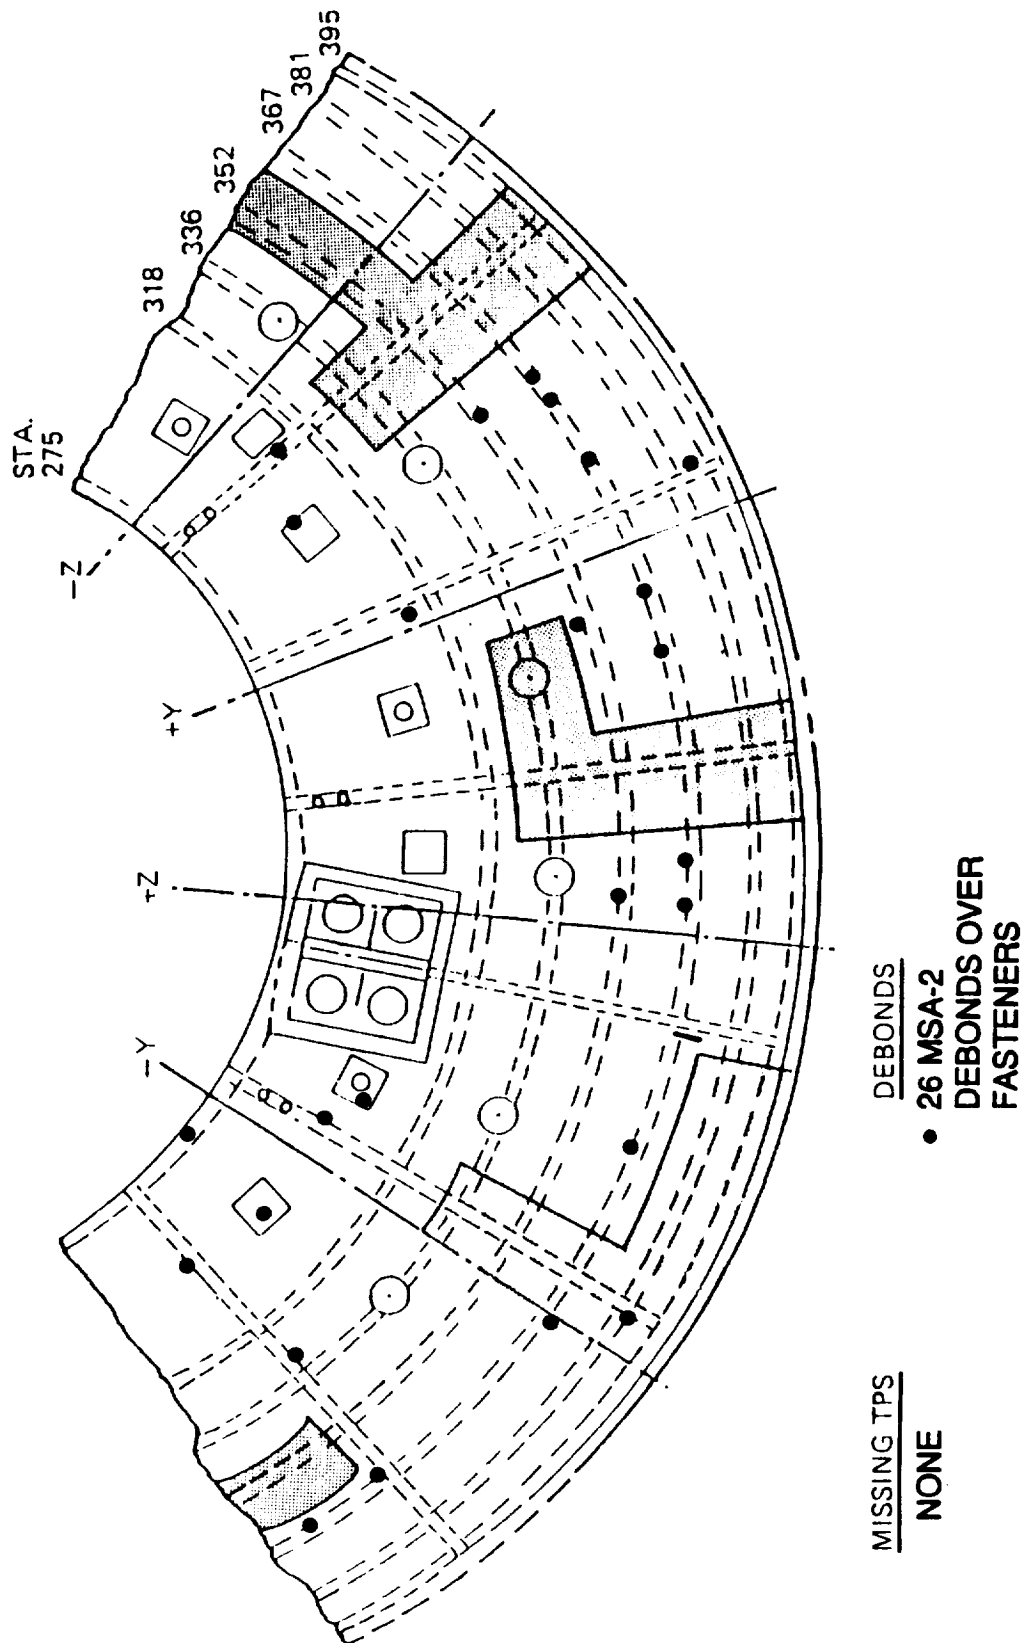
FIGURE 5. RIGHT SRB FRUSTUM

The nose cap was not recovered. The RH frustum had no areas of missing TPS but had 26 MSA-2 debonds over fasteners (Figure 5). All four BSM covers were in the open position, but had been bent by parachute riser entanglement.

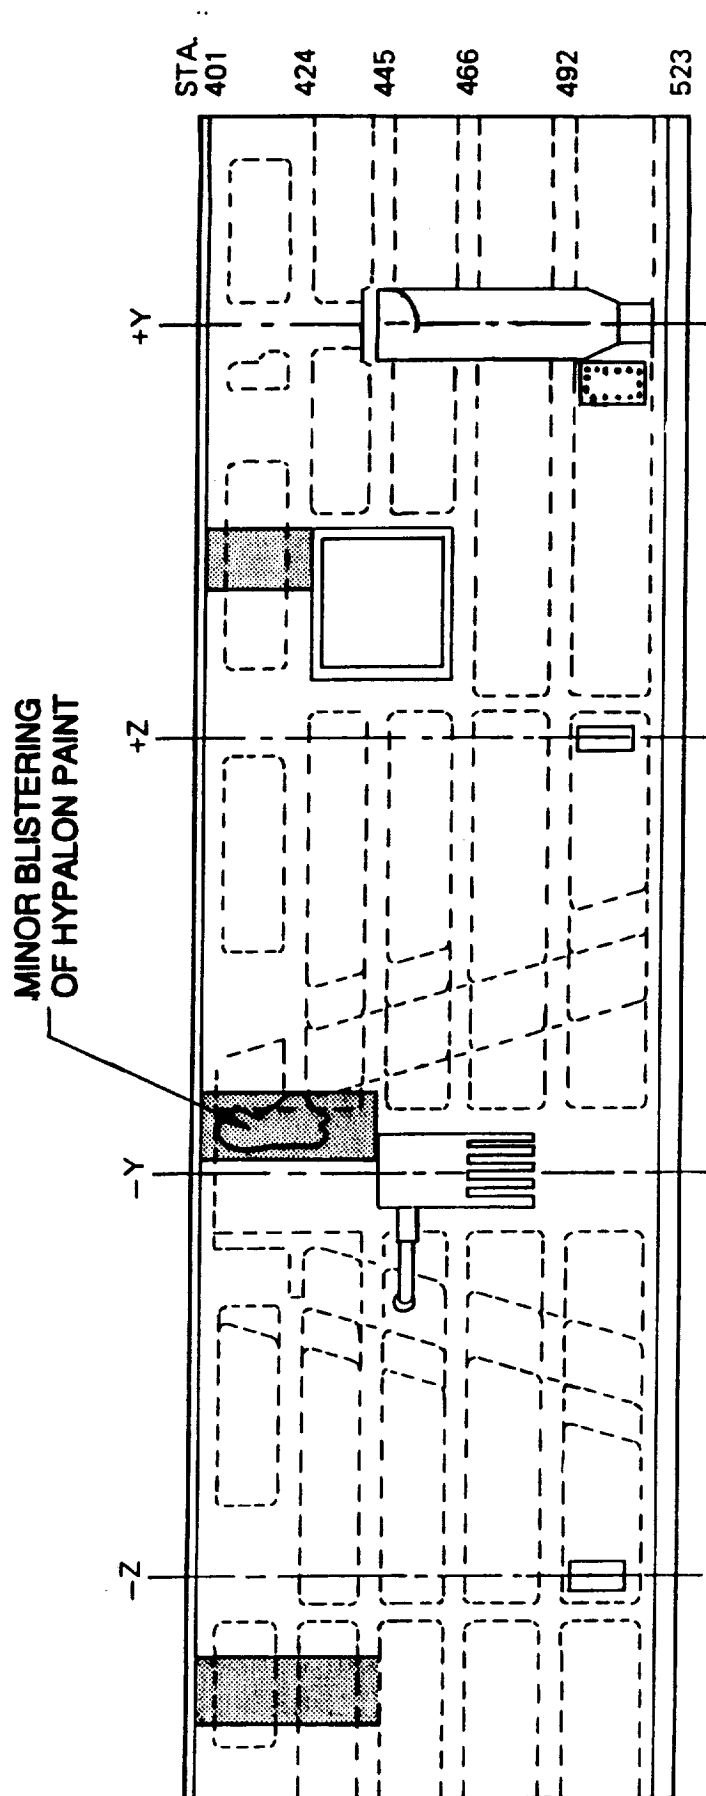
FIGURE 6. RIGHT SRB FWD SKIRT

The RH forward skirt exhibited no debonds or missing TPS. Minor blistering of the Hypalon paint occurred forward of the attach point (Figure 6). The phenolic plates on both RSS antennae were intact. The forward separation bolt and electrical cables appeared to have separated cleanly. No pins were missing from the frustum severance ring.

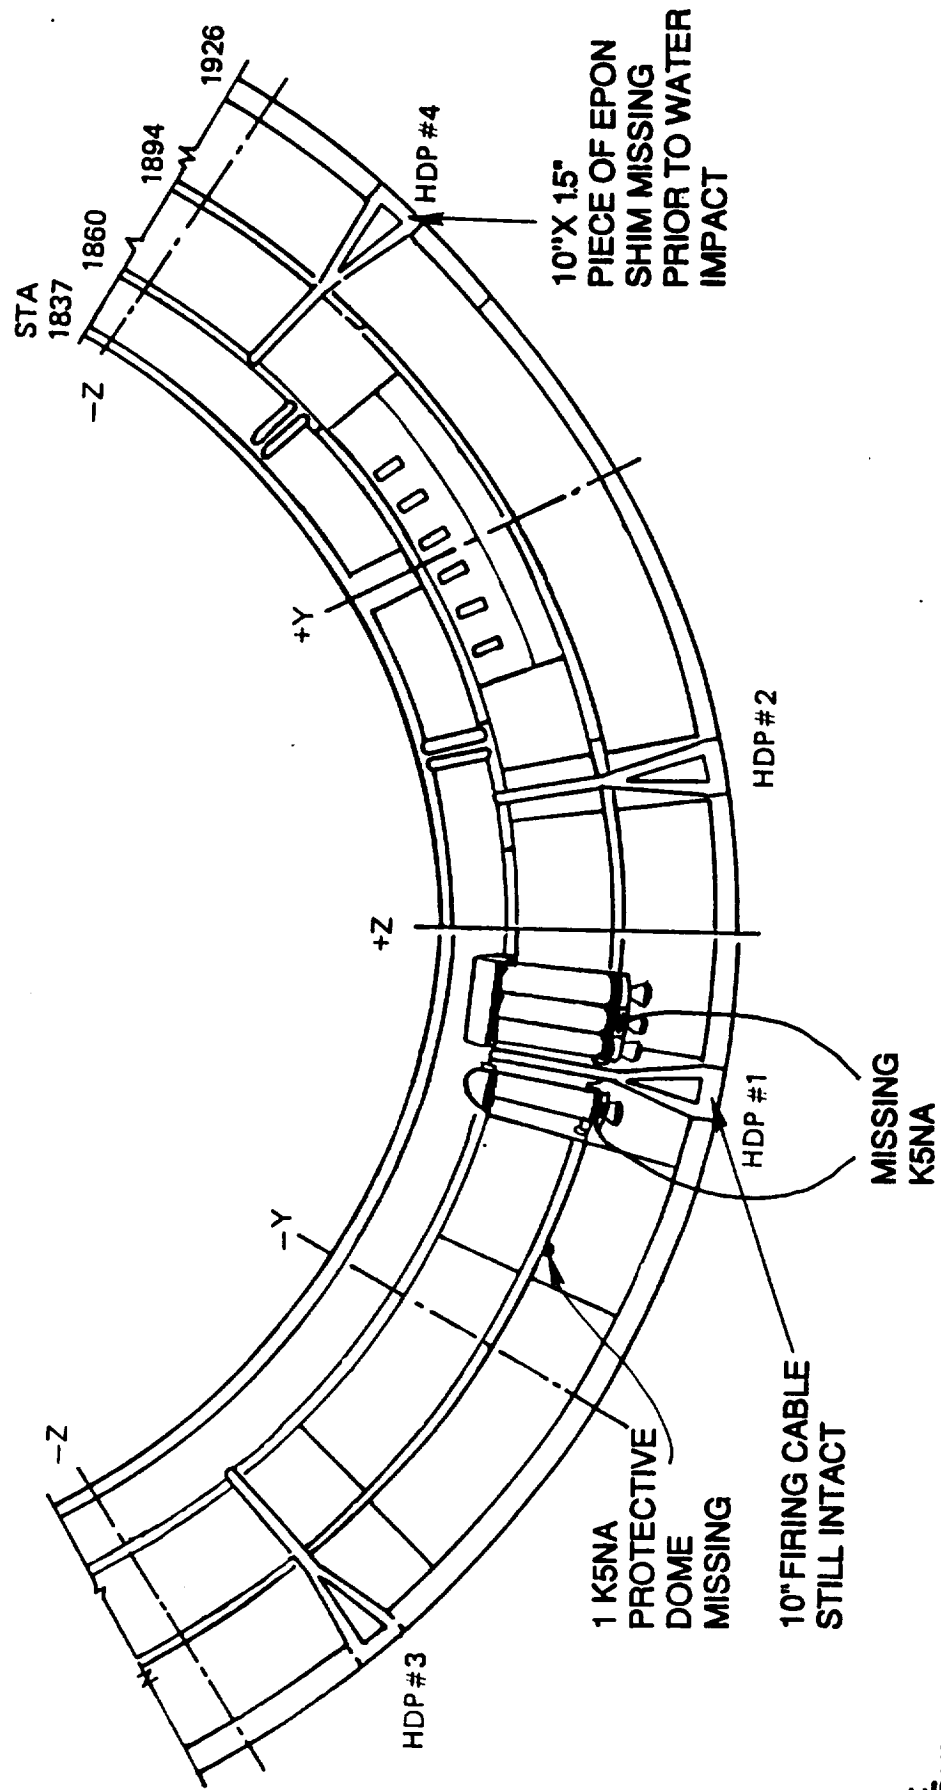
FIGURE 7. RIGHT SRB AFT SKIRT EXTERIOR TPS

The phenolic material on the kick ring delaminated in some locations. One of the K5NA protective domes was lost from the aft side of the phenolic kick ring prior to water impact. The aft skirt TPS acreage was in good condition with localized blistering of the Hypalon paint (Figure 7). K5NA was missing from all four aft BSM nozzles. Instafoam was missing from the aft ring around the aft skirt feet, HPU exhaust horns, and the SRB T-0 umbilical.

All four Debris Containment System (DCS) plungers were seated properly. Approximately 10 inches of pyrotechnic cable was still attached to HDP #1. A 10"x1.5" piece of EPON shim material was missing from HDP #4 prior to water impact.

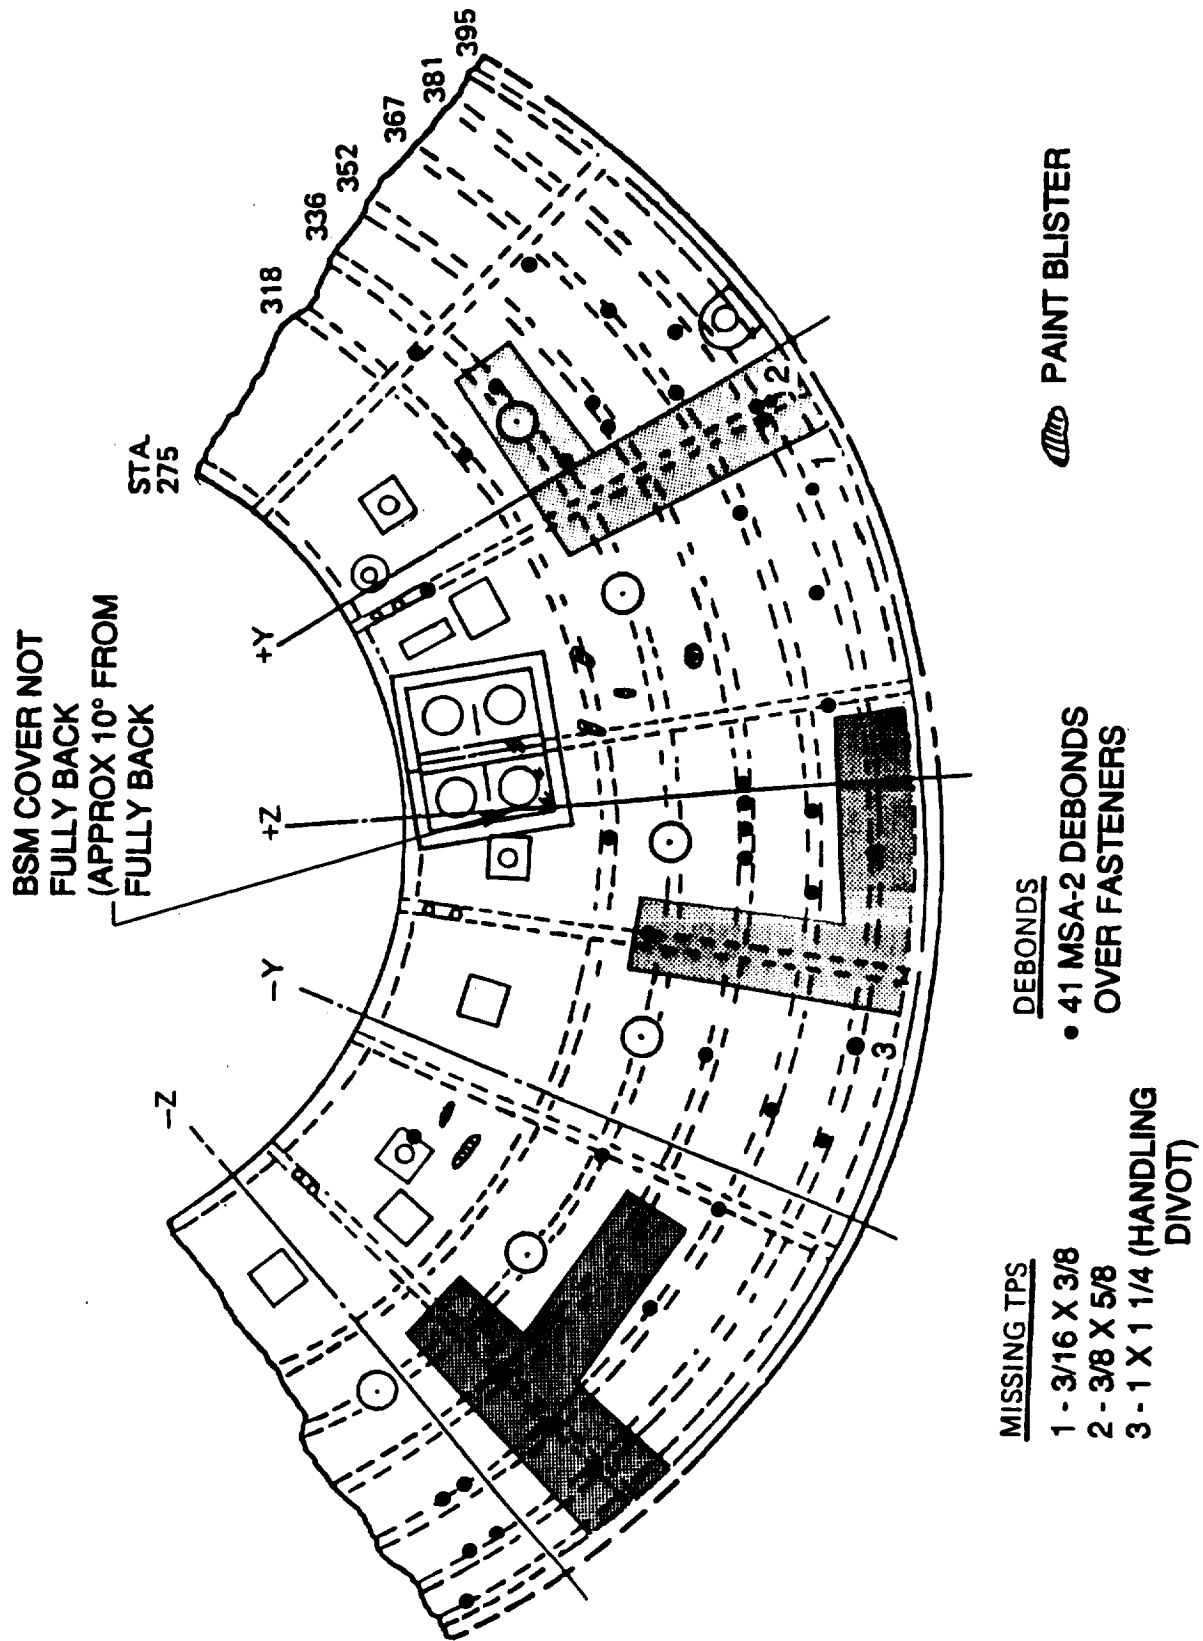
FIGURE 8. LEFT SRB FRUSTUM

The nosecap was recovered and showed no unusual damage. The LH frustum exhibited 2 areas of missing TPS and 41 MSA-2 debonds over fasteners (Figure 8). Minor blistering of the Hypalon paint occurred in localized areas. The BSM covers were intact and in the fully opened position.

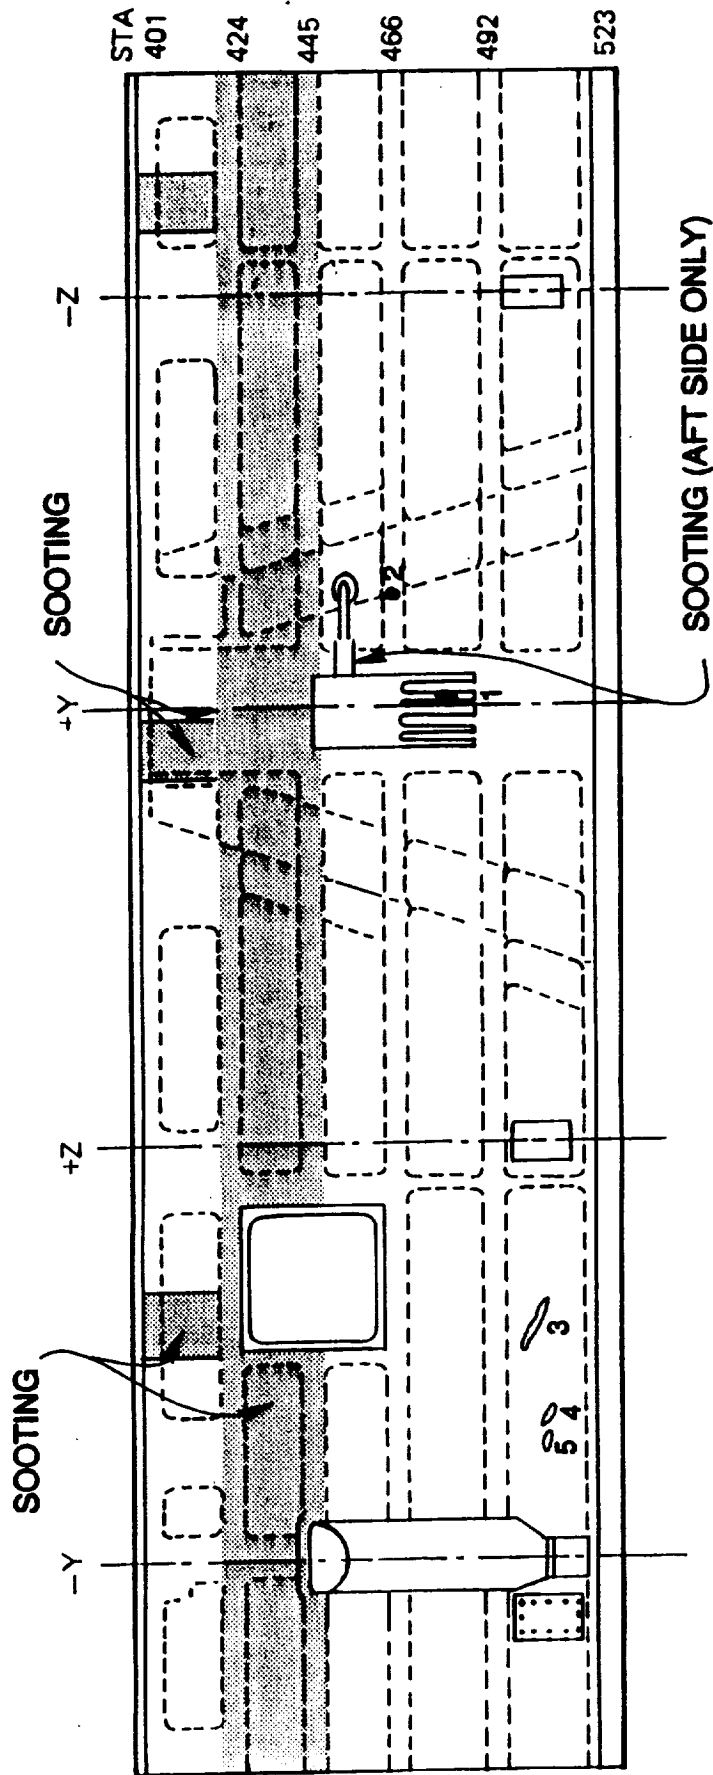
FIGURE 9. LEFT SRB FWD SKIRT

The LH forward skirt exhibited no debonds (see note about structural buckling). The phenolic plates on both RSS antennae were intact (Figure 9). The forward separation bolt and electrical cables appeared to have separated cleanly. No pins were missing from the frustum severance ring.

NOTE: The LH SRB forward skirt sustained damage in the area of the system tunnel. TPS (K5NA and MSA) was cracked and the metal substrate was buckled on both sides of the systems tunnel. Some of the Hypalon topcoat was missing. Initial assessment indicates the forward skirt damage was not a source of debris nor was caused by a debris problem. The most likely causes, according to MSFC, were unusual loads induced by water impact 'slapdown' loads or parachute deployment side loads.

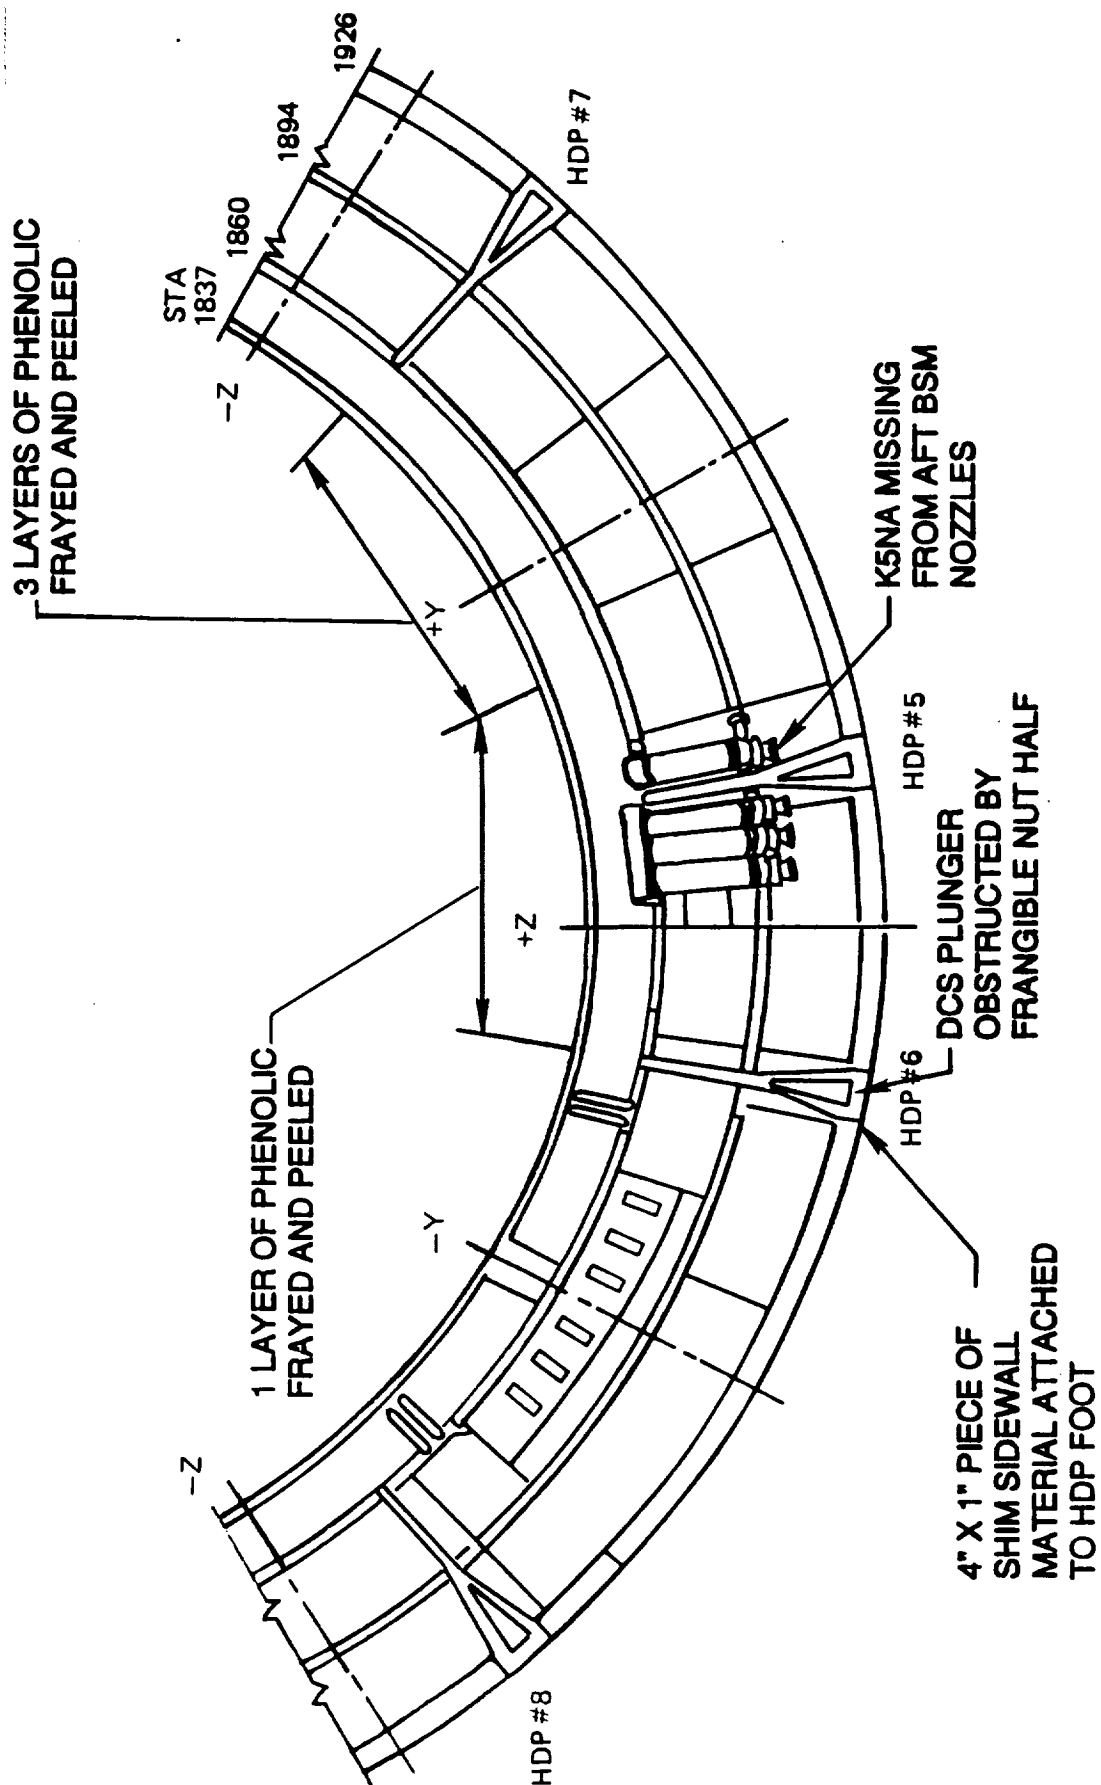
FIGURE 10. LEFT SRB AFT SKIRT EXTERIOR TPS

The phenolic material on the kick ring delaminated in several locations. None of the K5NA protective domes were lost from bolt heads on the aft side of the phenolic kick ring during ascent (Figure 10). The TPS over the aft skirt acreage was generally in good condition. K5NA was missing from all four aft BSM nozzles. Instafoam was missing from the aft ring around the aft skirt feet, HPU exhaust horns, and the SRB T-0 umbilical.

TPS MISSING
1 - 1" X 5"
2 - 1 1/2 X 5/8
3 - 2' X 1 1/2
4 - 6" X 1 1/2
5 - 6" X 1 1/2

NOTES:
NO TPS MISSING PRIOR
TO WATER IMPACT

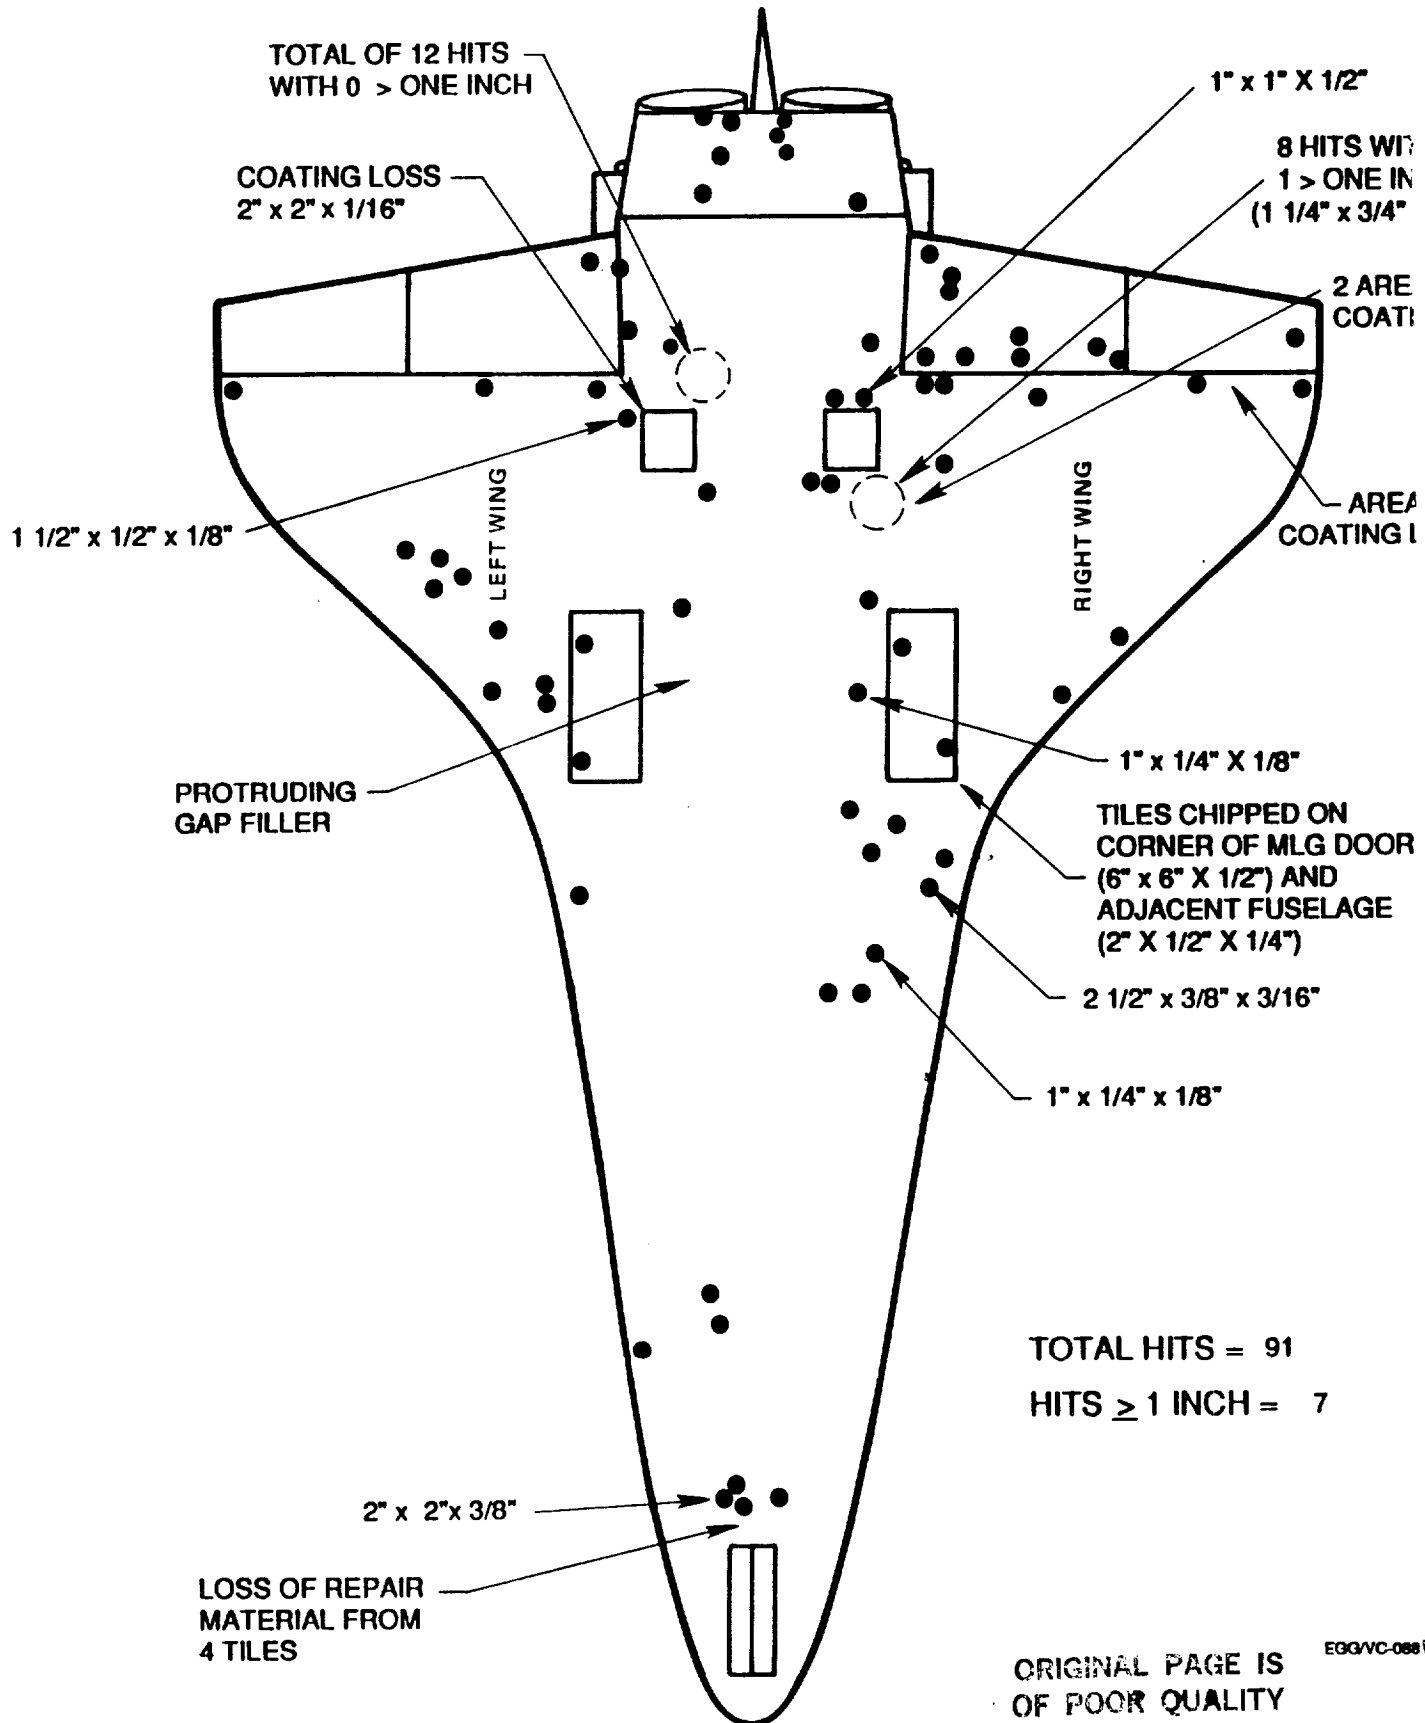
FIGURE 11. DEBRIS DAMAGE LOCATIONS

The Orbiter lower surface had a total of 91 hits of which 7 had a major dimension of one inch or greater. A comparison of these numbers to statistics from 25 previous missions of similar configuration (excluding missions STS-24, 25, 26, 26R, 27R, and 30R which had damage from known debris sources), indicates the total number of hits on the lower surface was greater than average, but the number of hits with a major dimension of 1" or larger was less than average. Figures 11-14 show the TPS debris damage assessment for STS-37. Figure 15 indicates the sites where samples were taken for laboratory chemical analysis.

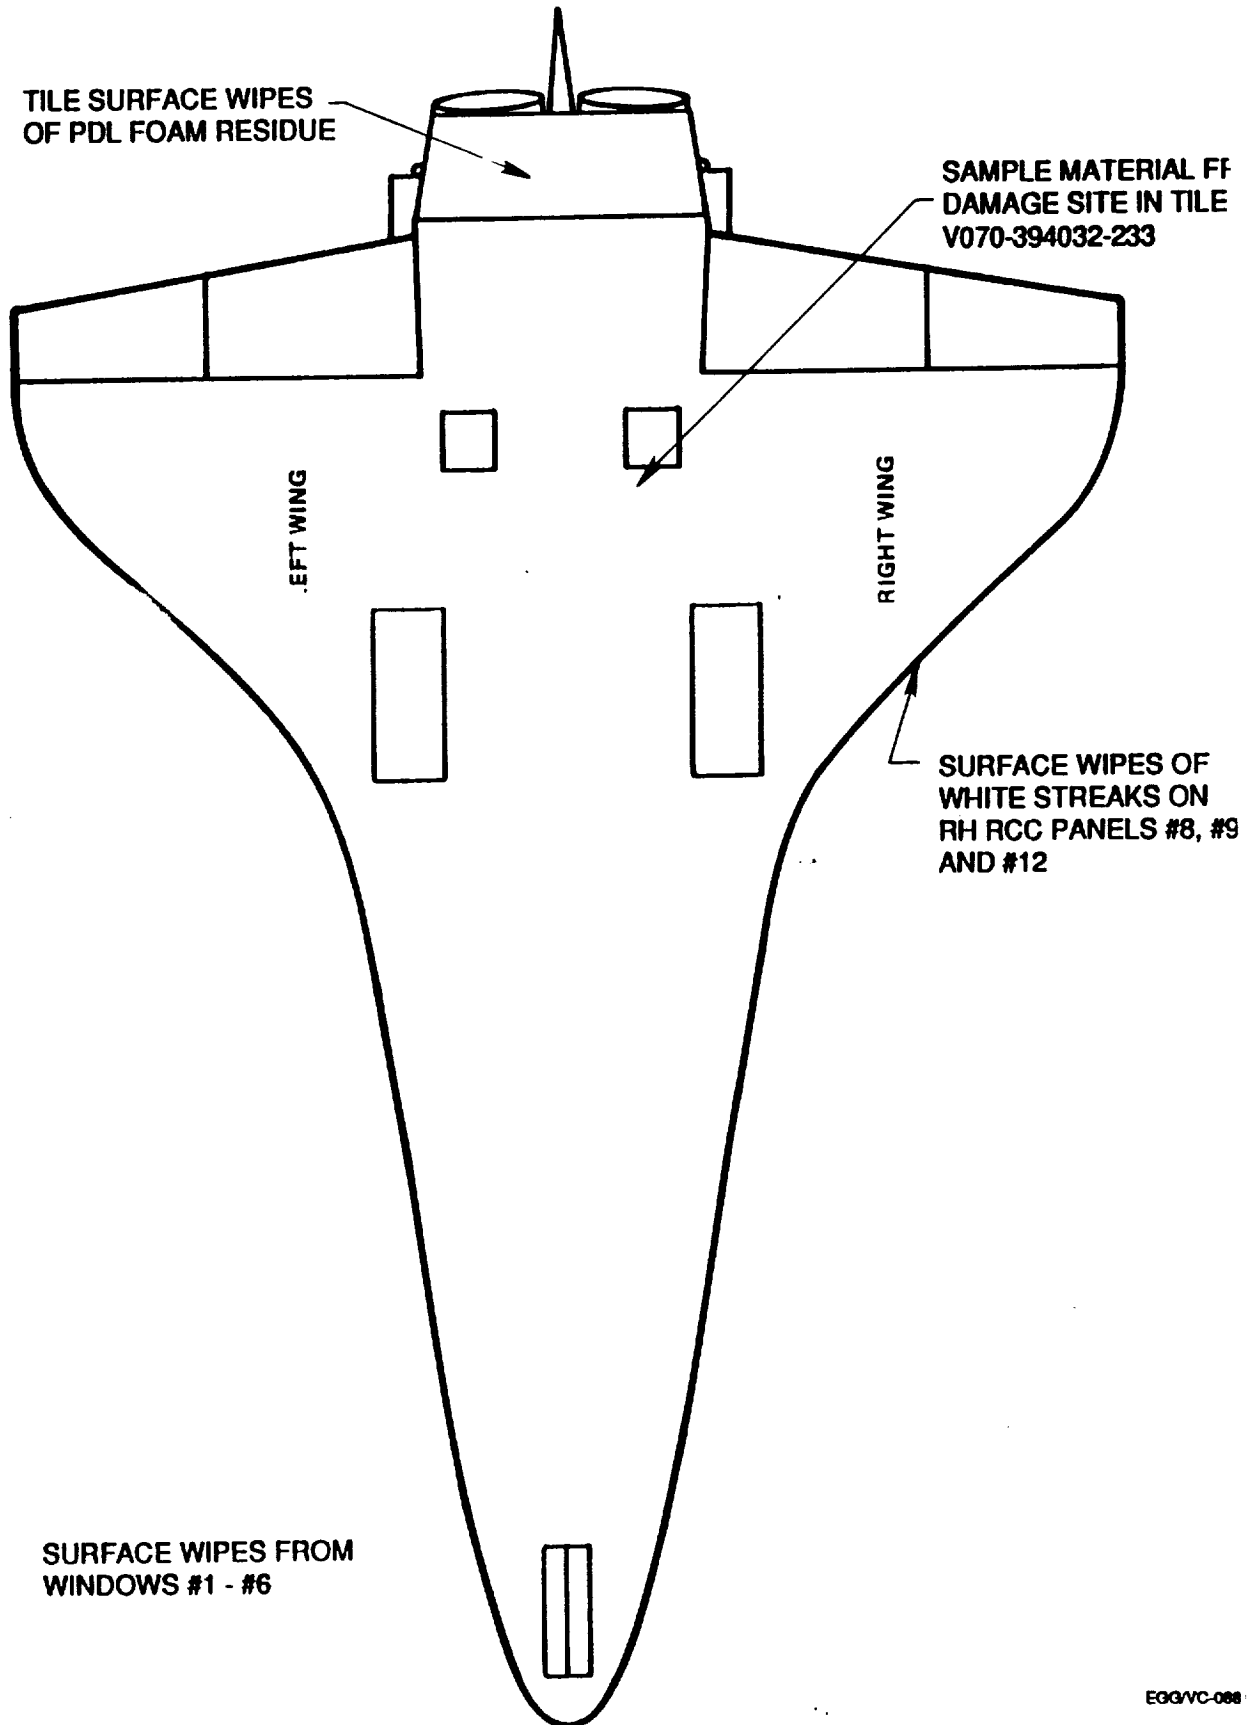
FIGURE 15. CHEMICAL SAMPLE LOCATIONS

A larger than usual quantity of white streaks were present on the RH wing leading edge RCC panels #5 through #17. The largest streak, on panel #8, was approximately 24" long by 4" wide. Only a few very small white streaks were present on the LH wing RCC panels. Samples of selected streaks were taken for laboratory analysis (reference Figure 15).

A total of 18 samples were obtained from Orbiter OV-104 during the STS-37 post-landing debris assessment at Ames-Dryden Flight Research Facility, California (Figure 15). The 18 submitted samples consisted of 8 Orbiter window wipes, 6 RH wing leading edge RCC samples, 3 wipes of Orbiter body flap tiles, and 1 tile debris sample. The samples were analyzed by the NASA-KSC Microchemical Analysis Branch (MAB) for material composition and comparison to known STS materials. The specific elemental analysis is shown in the appended MAB reports. Debris analysis involves the placing and correlating of particles with respect to composition, availability and thermal (mission) effects. Debris samples and analyses are provided by Orbiter location in the following summaries.

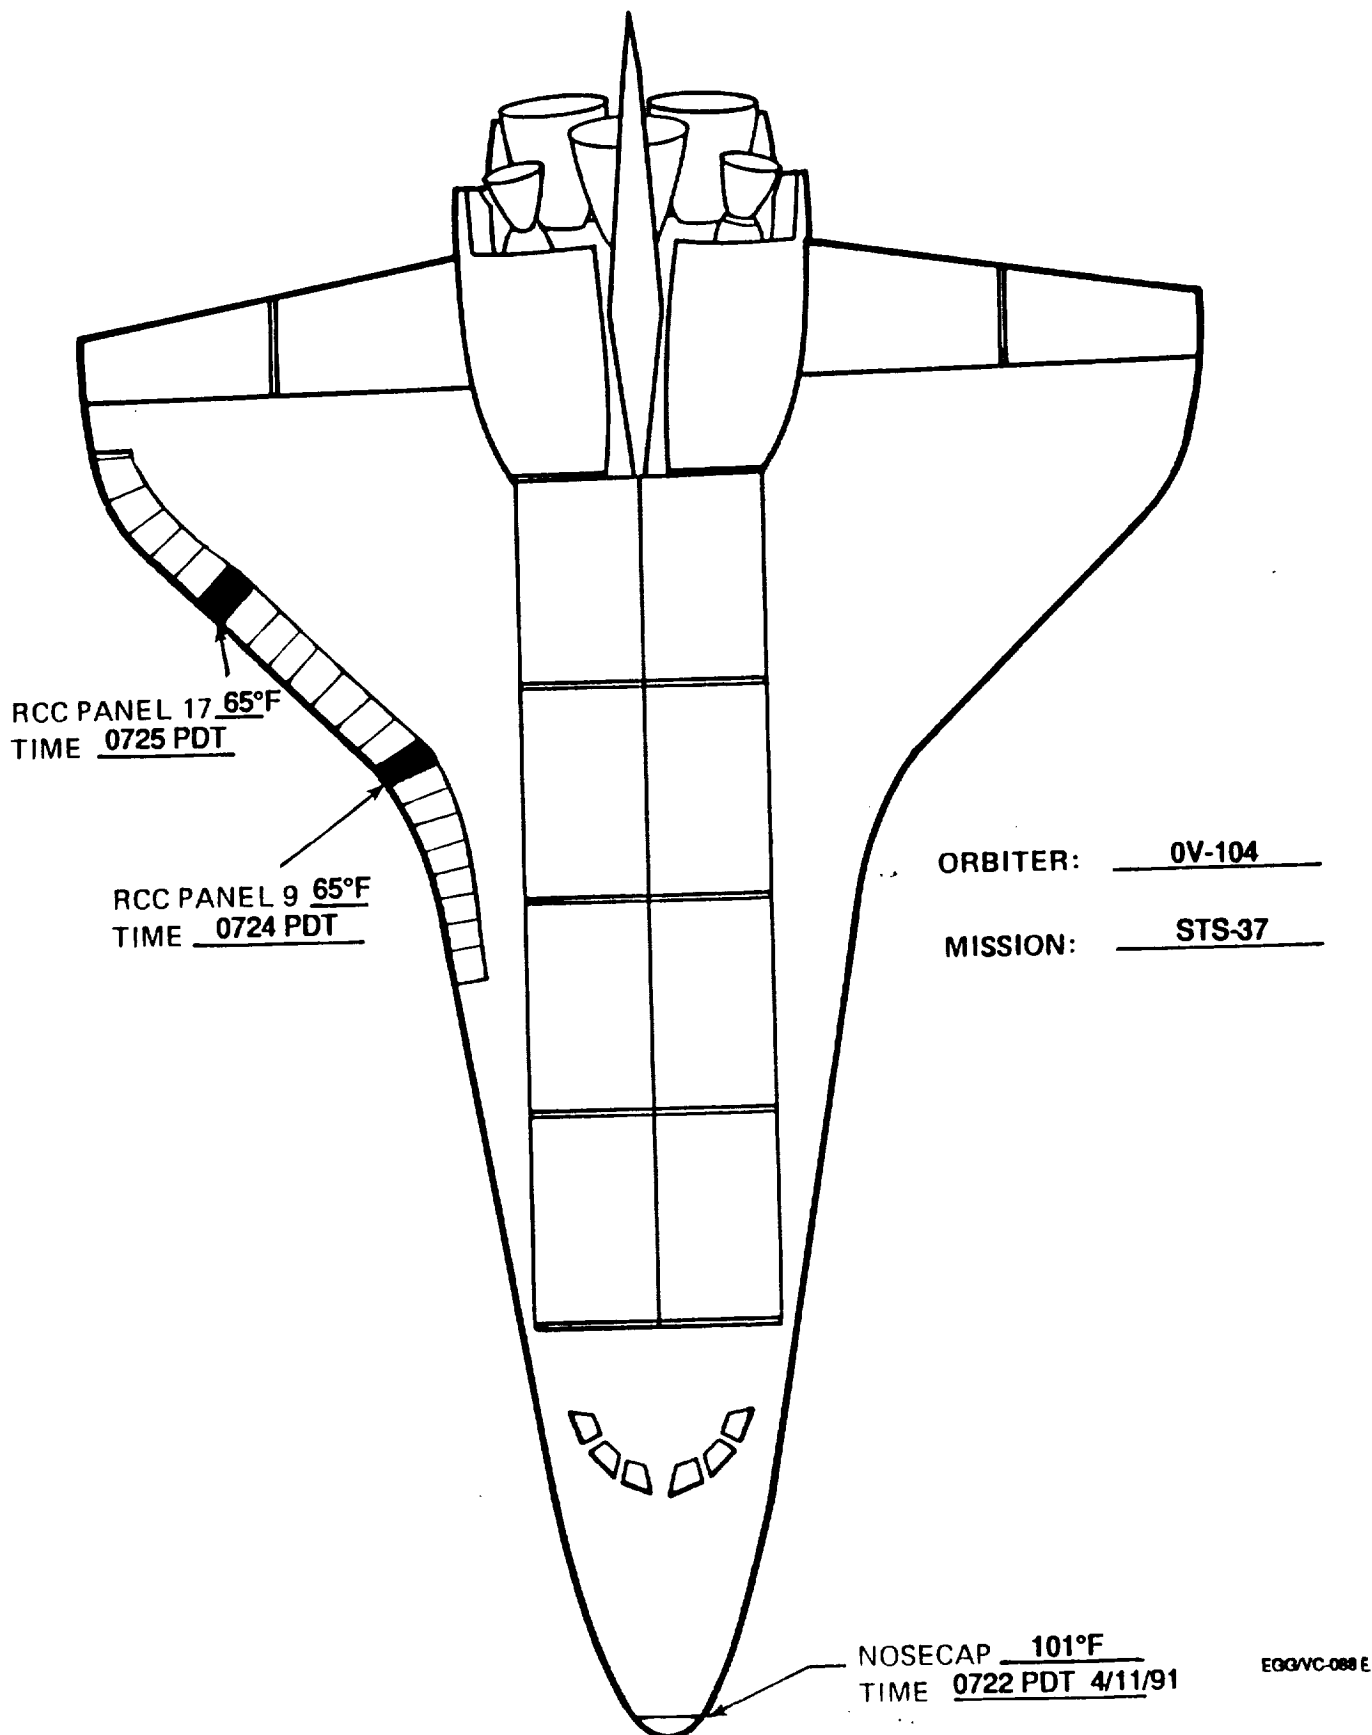
FIGURE 16. **STS-37 RCC TEMPERATURE MEASUREMENTS AS
RECORDED BY THE SHUTTLE THERMAL IMAGER
TEMPERATURE MEASUREMENTS**

The KSC Shuttle Thermal Imager (STI) was used to measure the surface temperatures of several areas. Twenty-seven minutes after landing the Orbiter nose cap RCC was 101 degrees F and both the RH wing leading edge RCC panels #9 and #17 were 65 degrees F (reference Figure 16). These temperatures were lower than usual due to the low ambient temperature and high winds.

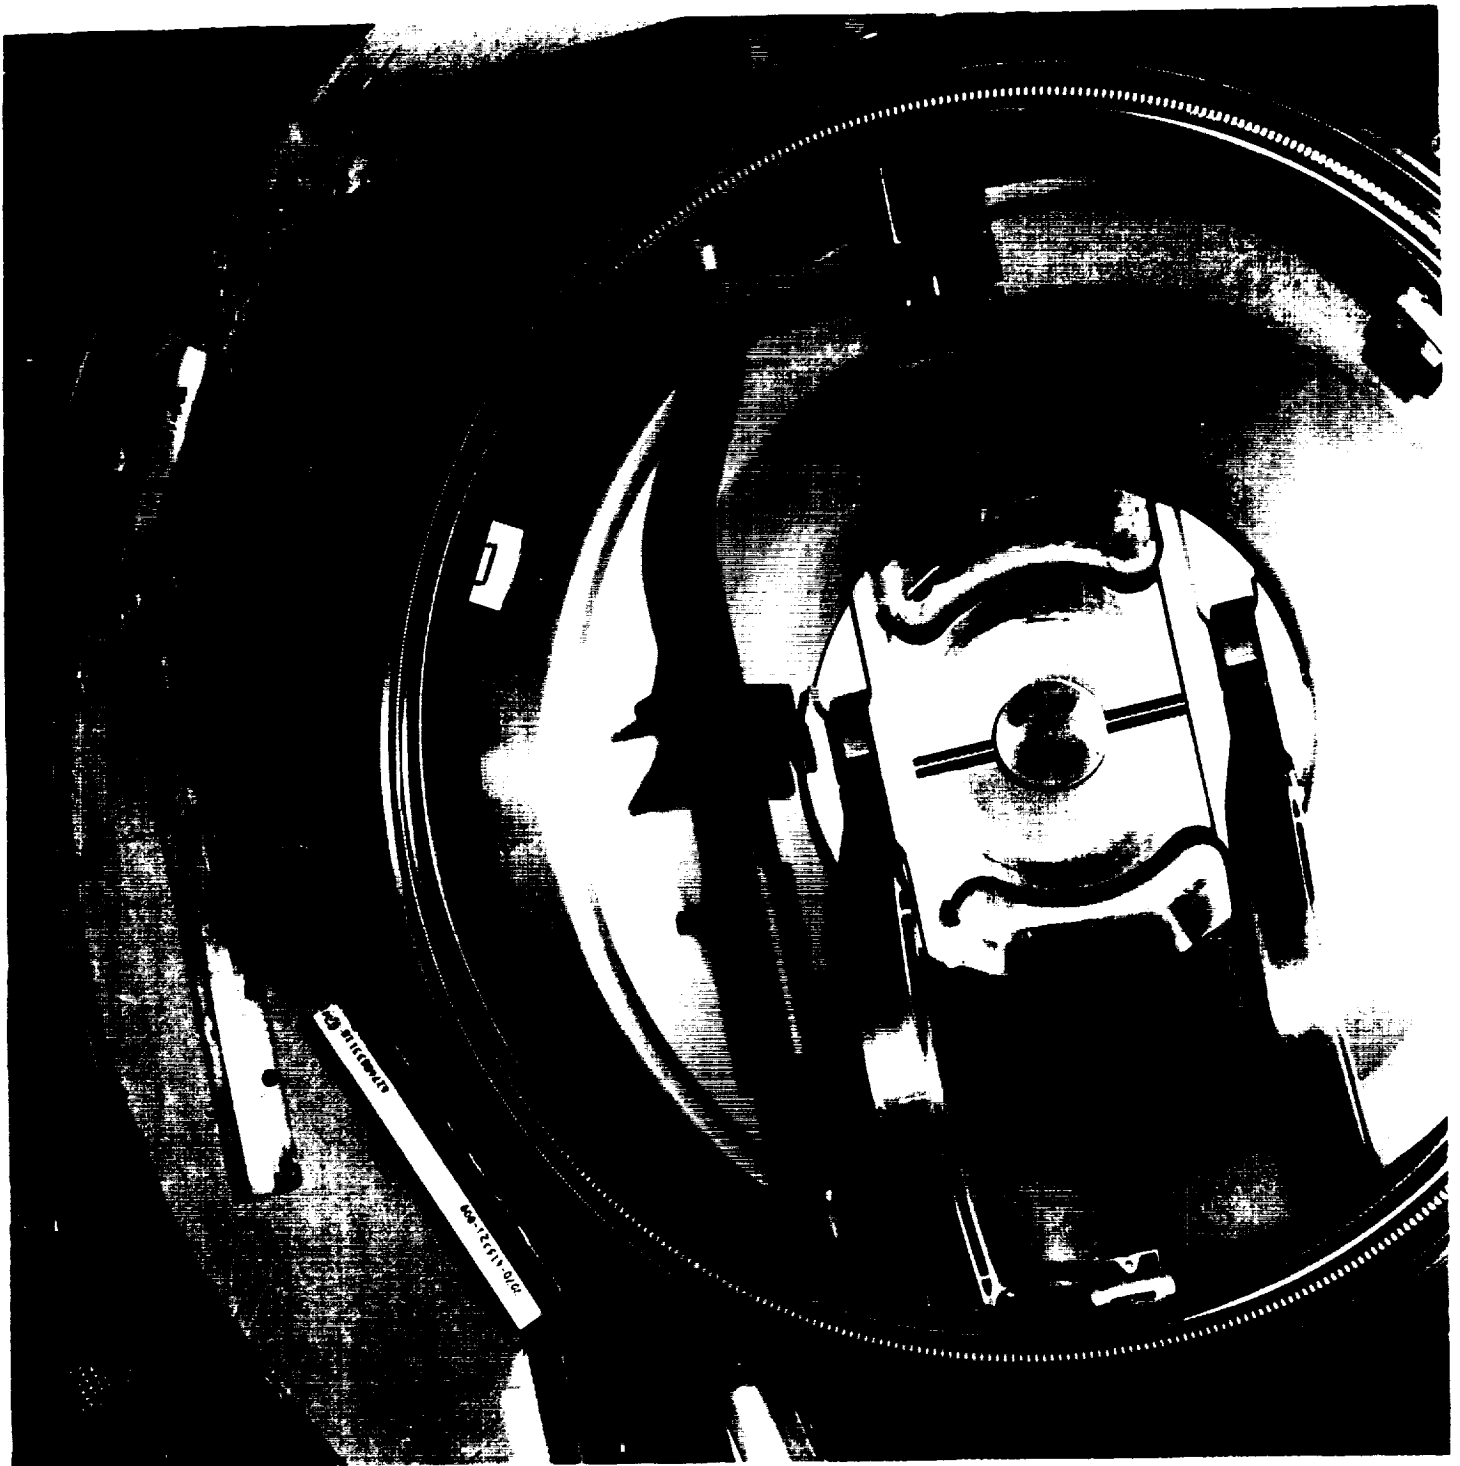
A lightning protection contact fell onto the runway when the LH2 ET/Orbiter umbilical door was opened. This contact, which is approximately 17.5" long by 2.5" wide, is normally bonded to the ET half of the LH2 umbilical and should have stayed with the ET after separation. Subsequent laboratory analysis revealed adhesive failure with very little adhesive present on the inner surface (bonding side of the part to the umbilical). There was no evidence of foam material or contaminants. The

polyurethane adhesive had been poorly cured. The cause of the bonding problem is unknown, but the use of self tapping screws to secure the lightning contact is under review. The new 14 inch disconnects were designed with fastened lightning protection contacts.

Lightning protection contact that fell onto the runway when the LH2 ET/ORB umbilical ET door was opened. The contact is normally bonded to the ET half of the umbilical and should have stayed with the ET after separation.

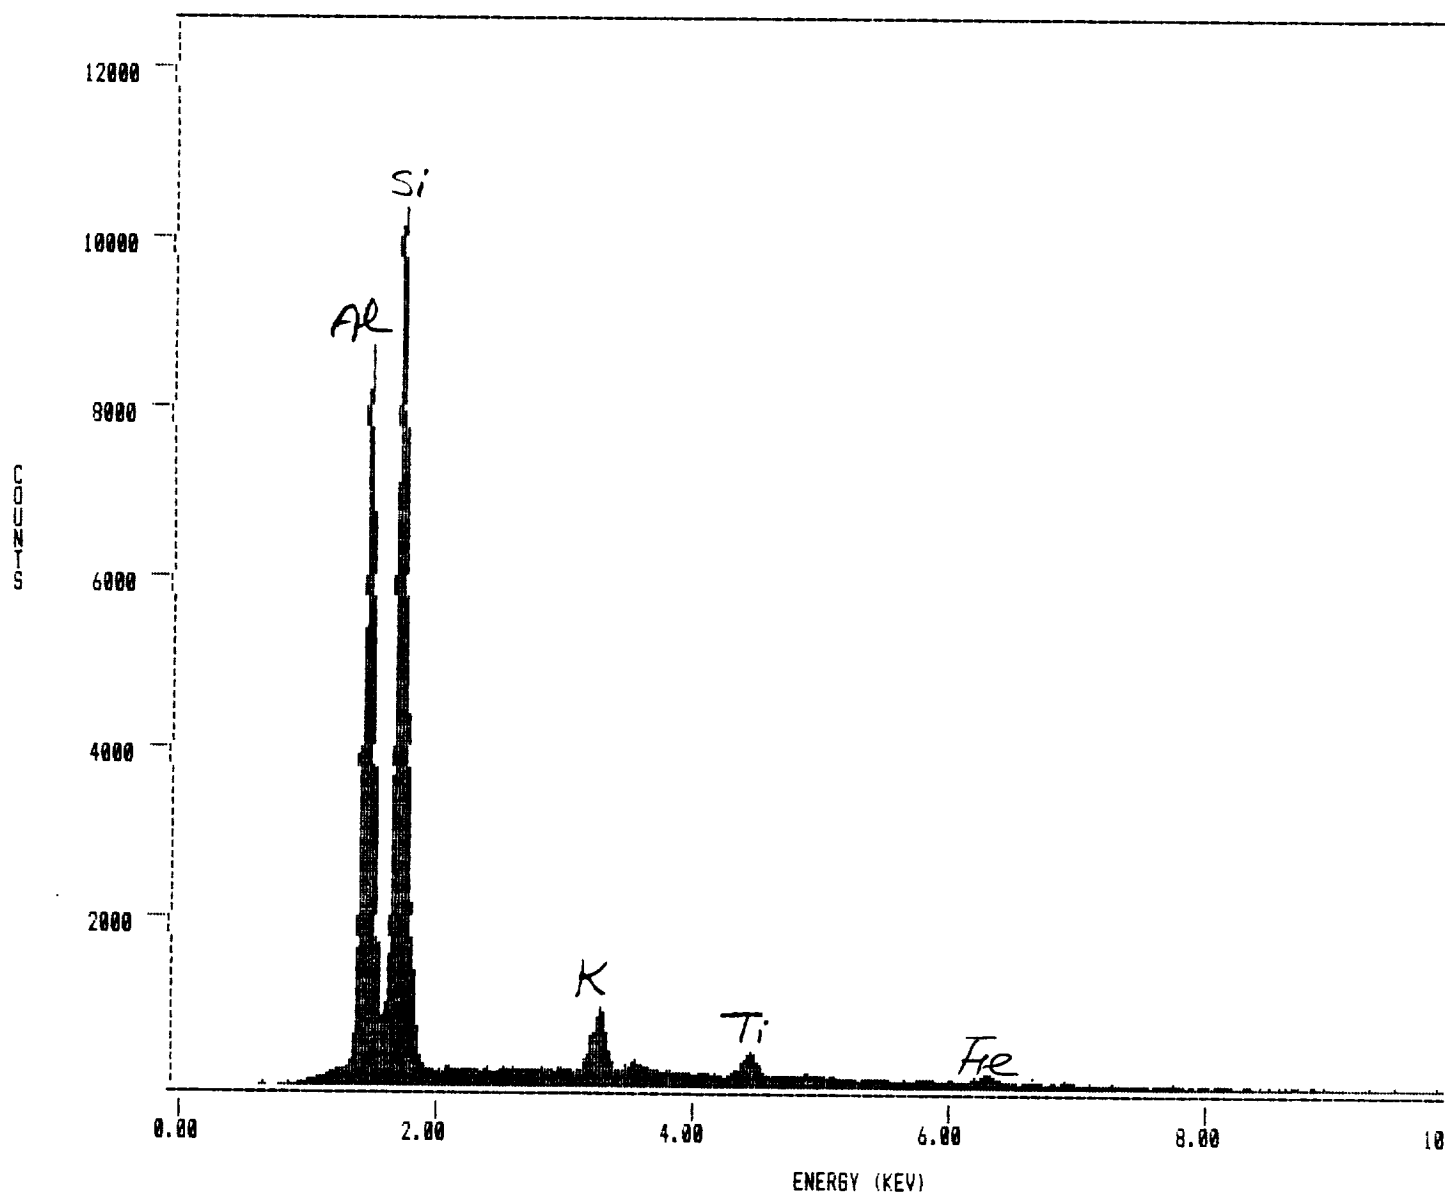
Figure 4 HYPALON, AS RCVD, 988-90
